**Benton District Historic Resources  
Survey and Inventory**

*Prepared by*  
**Diana J. Painter, PhD**  
**Sonoma State University**

*for*  
**Anth. 592 – Special Topics in CRM**

**Fall 2004**

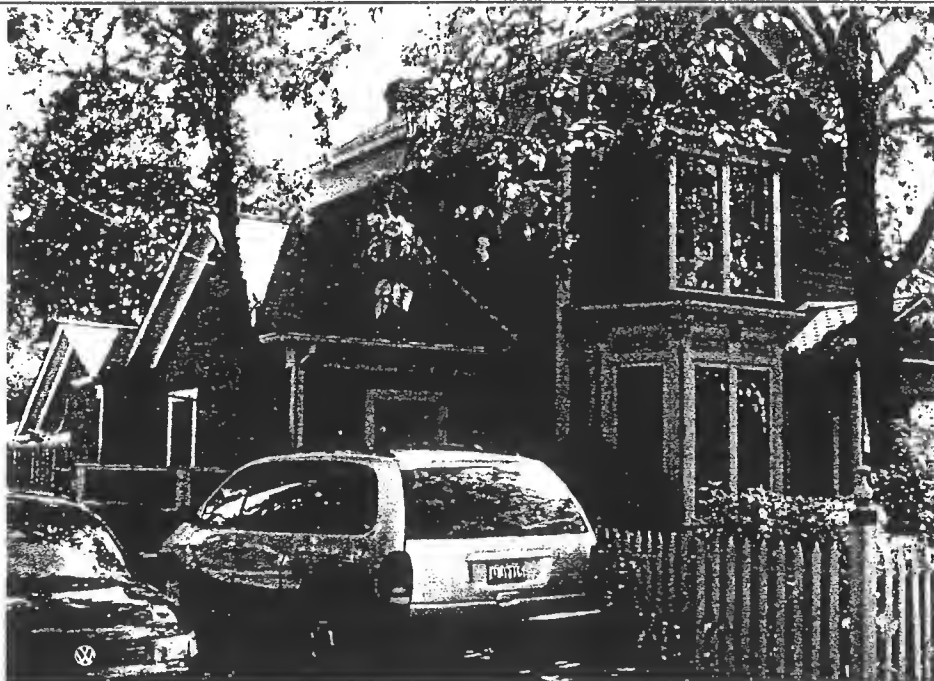
This two-story 1890 residence with Italianate influences is located at the northeast corner of the intersection of Beaver and Benton streets, with the front façade facing west onto Beaver street. It is wood frame construction with, a concrete perimeter foundation, and an irregular footprint. The cross-gabled roof has a moderate pitch, composition shingles, cornice returns, and decorative braces.

View of front façade, photo facing southeast.

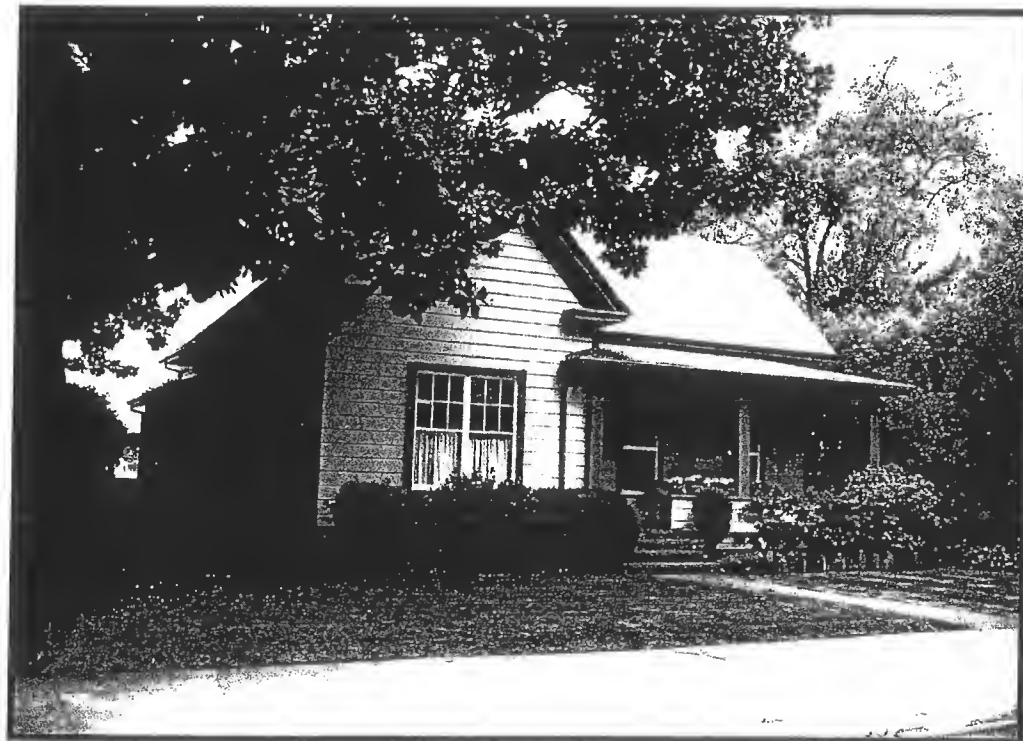
\*P3a. Description This is a one-story residence on the northwest corner of Beaver and Benton. The house has two entrances, one facing east and one facing south. The main entrance appears to be the east-facing one, at 805 Beaver. The house has a nearly square layout, with an attached single car garage. It has a moderately pitched, cross-gable composition shingle roof with slight overhangs and cornice returns on the front-facing gable. The wood frame house has a plain, boxed cornice. It has tongue-and-groove siding, a poured concrete foundation and concrete sidewalk leading to porch. The main entrance has brick steps to the half-width open porch, which is inset in the L. The porch supports are heavy square wood posts. The door has four panels in two tiers, with a transom window. The windows on the east side of the house are six-over-one-light, double-hung, with plain trim (see Continuation Sheet)

P5b. Description of Photo:  
View of 805 Beaver St.,  
facing East

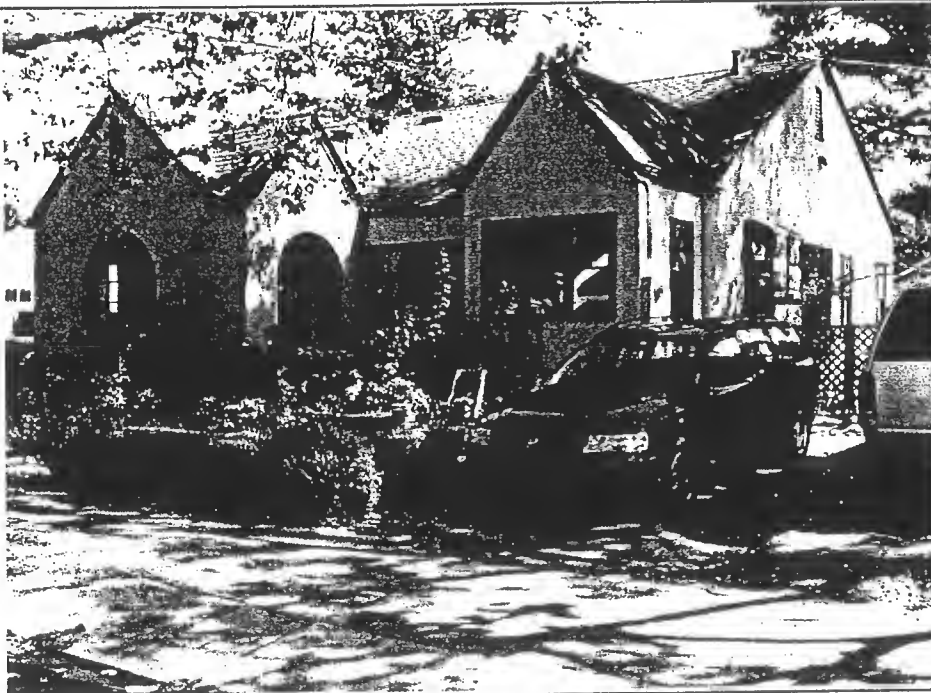
This 1932 Tudor Revival one-and-one-half story residence is located on Beaver street north of the intersection of Beaver and Benton streets, with the front façade facing west onto Beaver street. It is a wood frame construction with a concrete perimeter foundation and a U-shaped footprint. The cross gable roof has a steep pitch with no eaves and composition shingles.

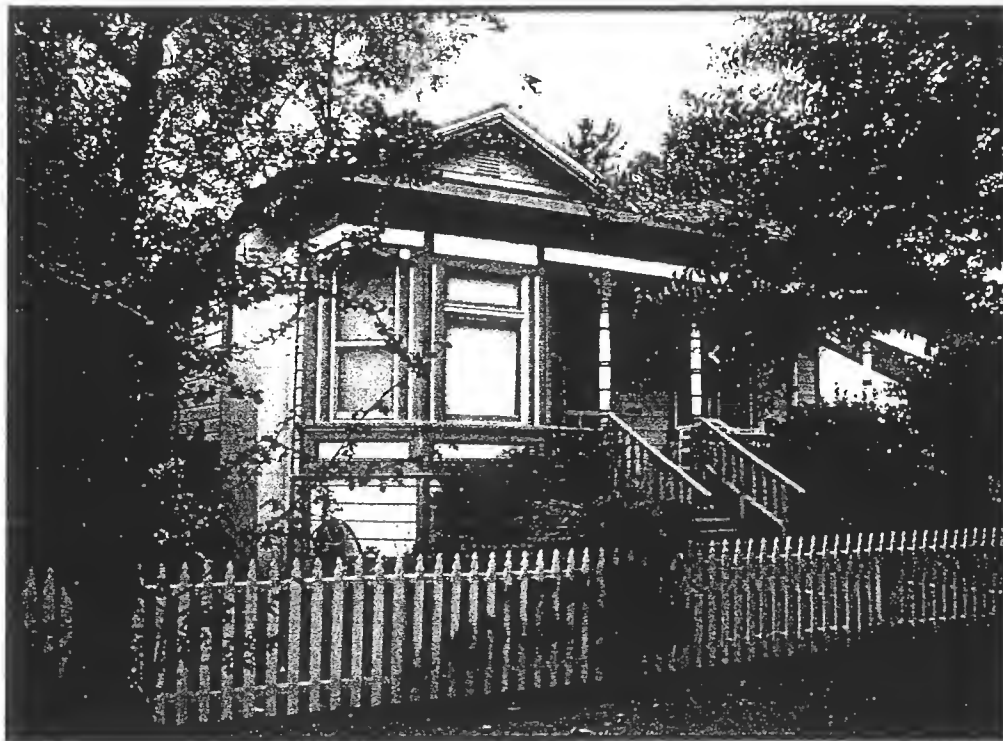
P5b. Description of Photo:  
View of 811 Beaver St.,  
facing East

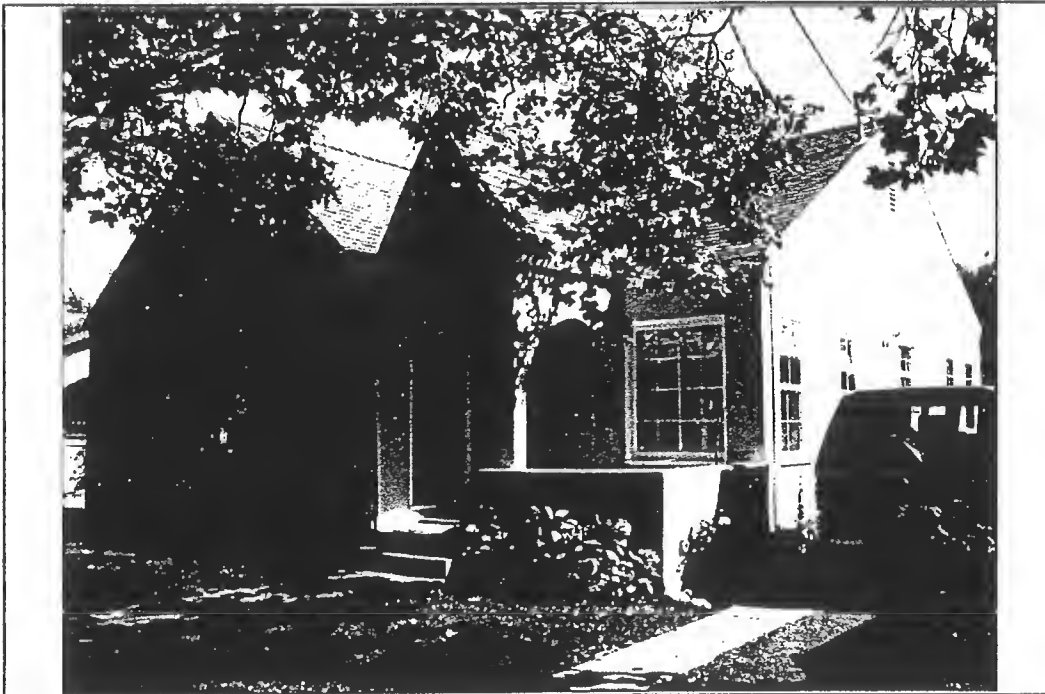
P5b. Description of Photo:  
View of front façade, photo  
facing northeast

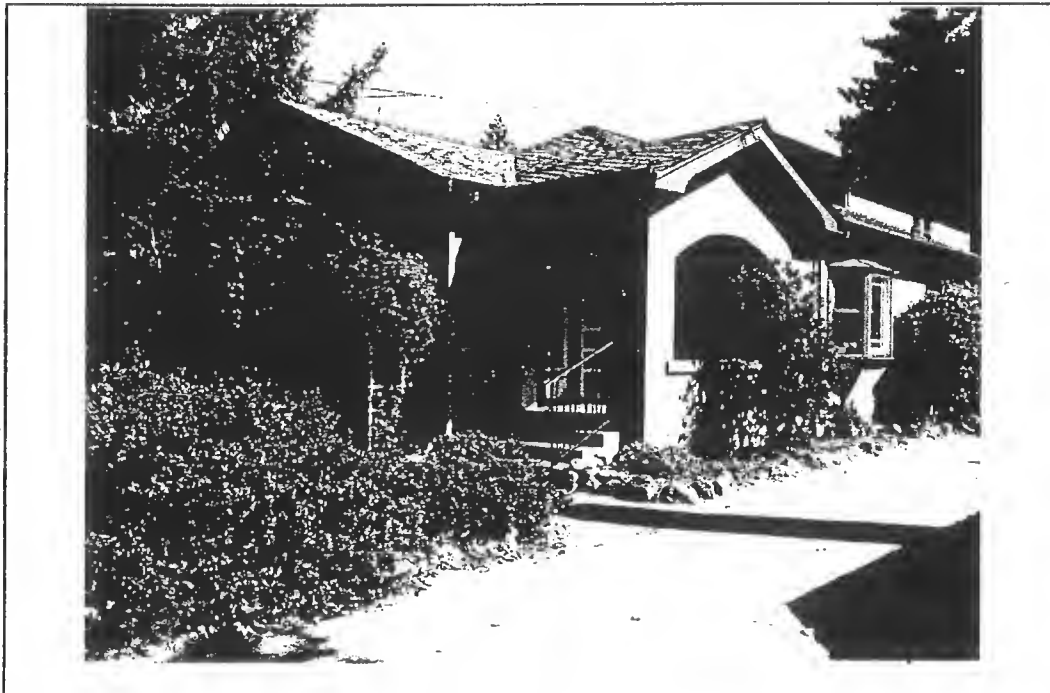
This 1927 one-and-one-half story residence with a two-story addition is located south of the intersection of Beaver and Howard streets, with the front façade facing west onto Beaver street. It is wood frame construction with a concrete perimeter foundation and an irregular footprint. The cross-gable-on-hip roof has a moderate pitch, overhanging eaves, and composition shingles. The house has a stucco finish with lattice at the apex of the front gable. The front façade features a front-gable porch on the south end of the house, with arched openings on the west and south sides, covering the south-facing door. North of this is a slant-sided bay window with a sloping roof featuring a one-over-one wood sash window on each side and a decorative single-light fixed window in the center.

View of front and south façade,  
Photo facing northeast

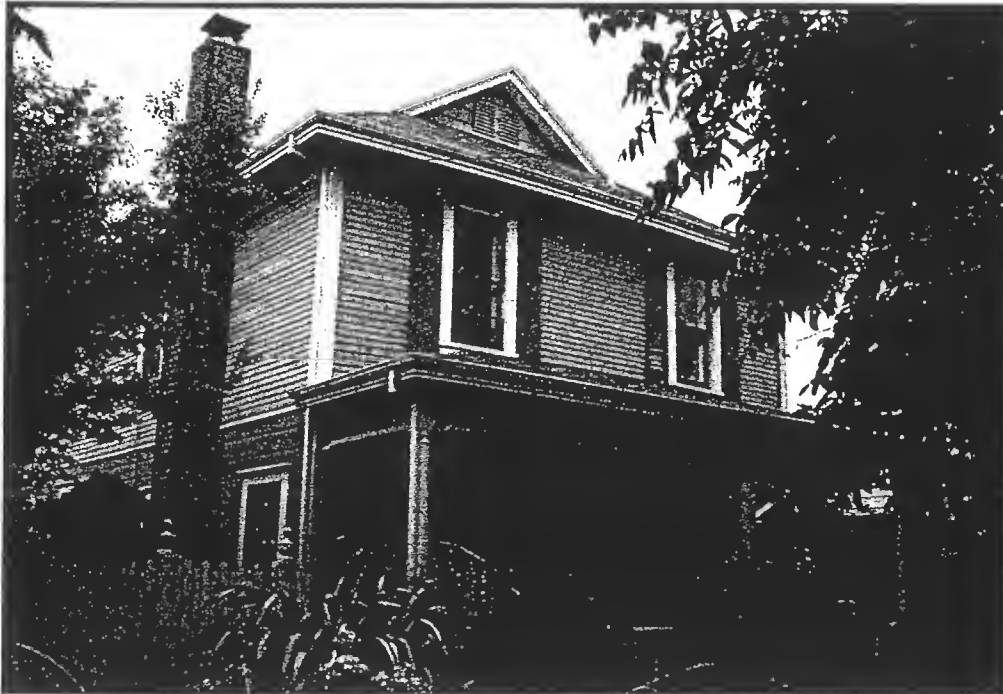
This 1905 residence is twostories, with a square footprint, and a gable-on-hip roof. It is oriented to the east, toward Beaver Street. It is wood frame construction with a concrete foundation. The first story is finished with channel siding, the second with what appears to be a narrow clapboard siding. The two stories are visually separated by a full-width front porch that has a shallow hipped roof and spindlework under the boxed eaves.

P5b. Description of Photo:  
823 Beaver Street residence; view  
to northwest.

All of the windows on the front facade are double-hung with one-over-one lights; on the first floor, three are part of the bay window on the left hand side of the door with a single double-hung window to the right of the door. On the second story, stained glass panes have been set behind the two symmetrically-placed double-hung windows. The first story windows and door have crown molding. Louvered shutters flank each second story window. The façade of the house is characterized by quite a bit of spindlewood decoration, as is common in the Folk Victorian style. The porch features turned supports with delicate fan-like wood insets bordering the top and incorporated into the railing at the bottom of the porch. A plain frieze band is located below the cornice under the eaves. A brick exterior chimney is located near the front of the house on the left (south) wall.

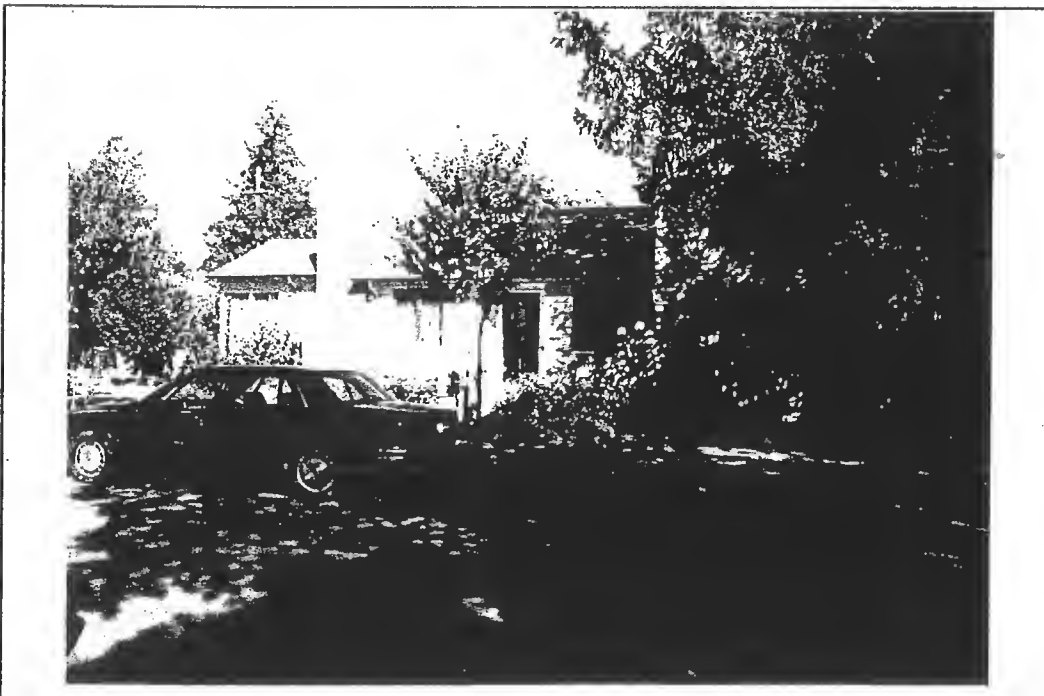
P5b. Description of Photo:  
View of front façade, photo  
facing east

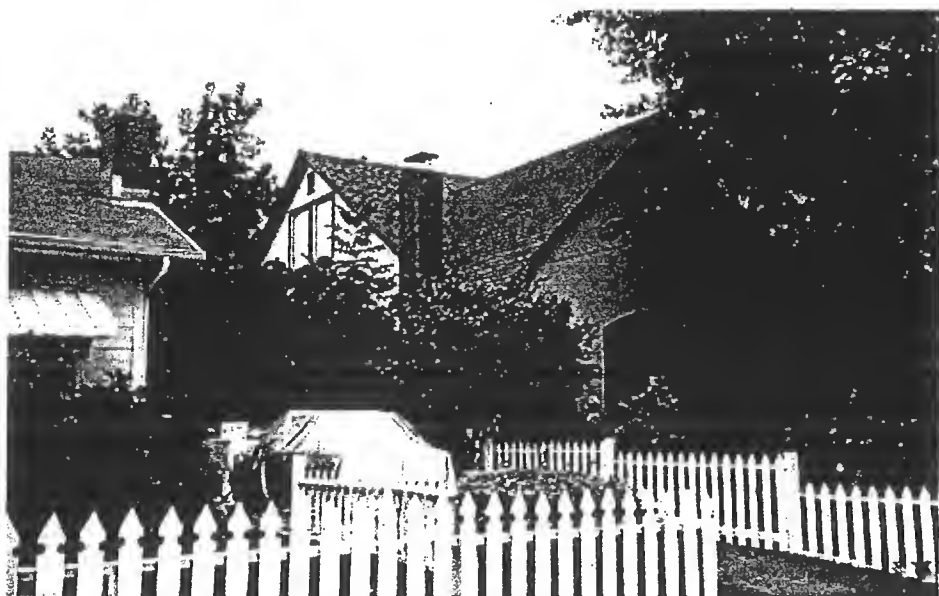
Additional photo description: Northeast elevation viewed from Beaver Street. October 4, 2004; Accession # 8377140-R1-026-11A.jpg

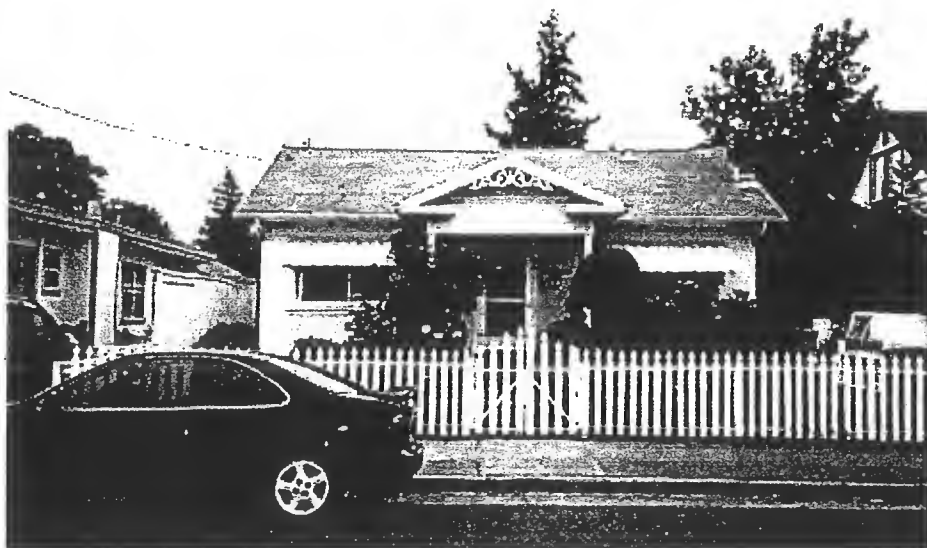
P5b. Description of Photo: East elevation viewed from Beaver Street; October 4, 2004; Accession #8337748-R1-022-9A.jpg

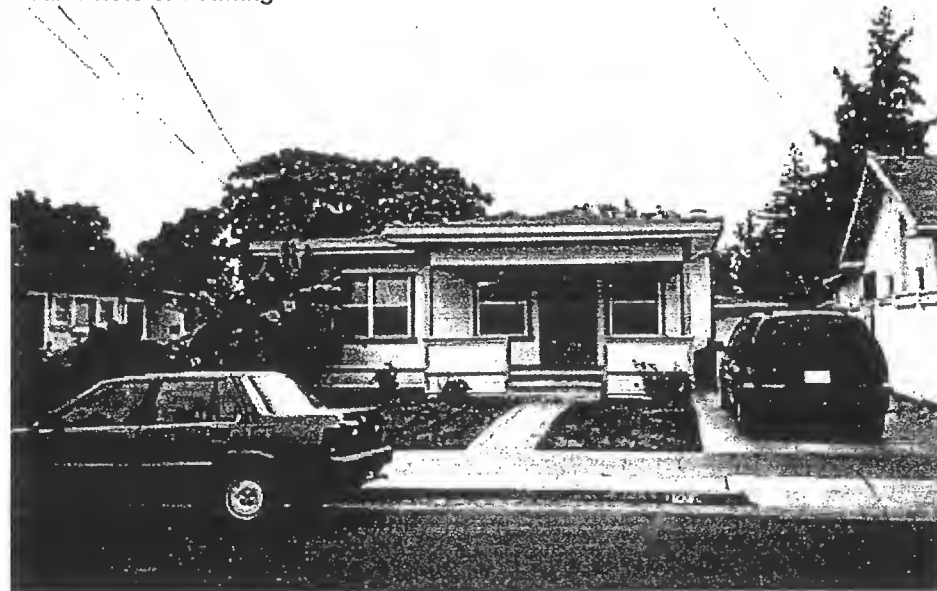
P5b. **Description of Photo:**  
West elevation viewed from  
Beaver Street; October 4,  
2004; Accession #8337748-R1-  
018-7A

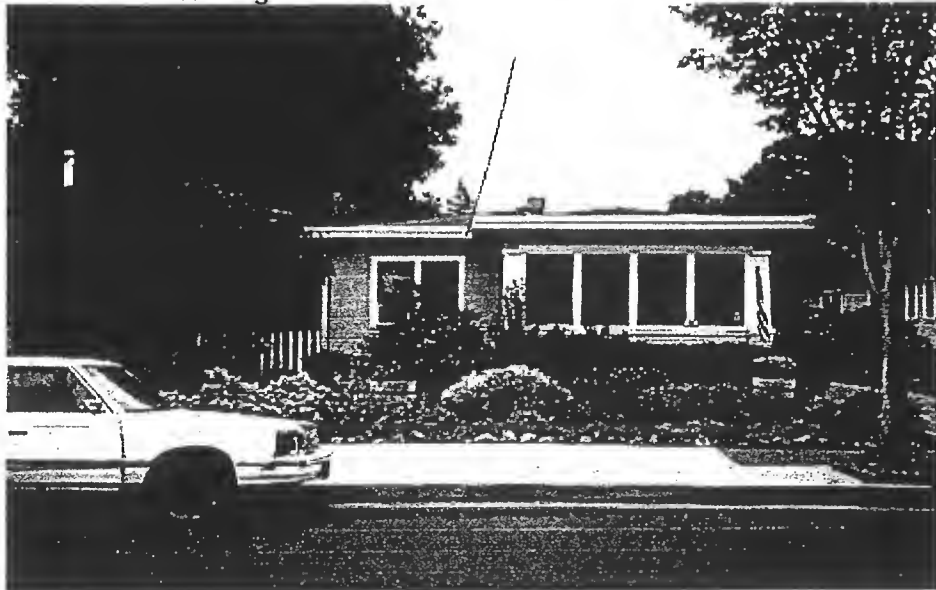
P5b. Description of Photo: east elevation viewed from Beaver Street; October 4, 2004; Accession #8337748-R-1-008 2A.jpg

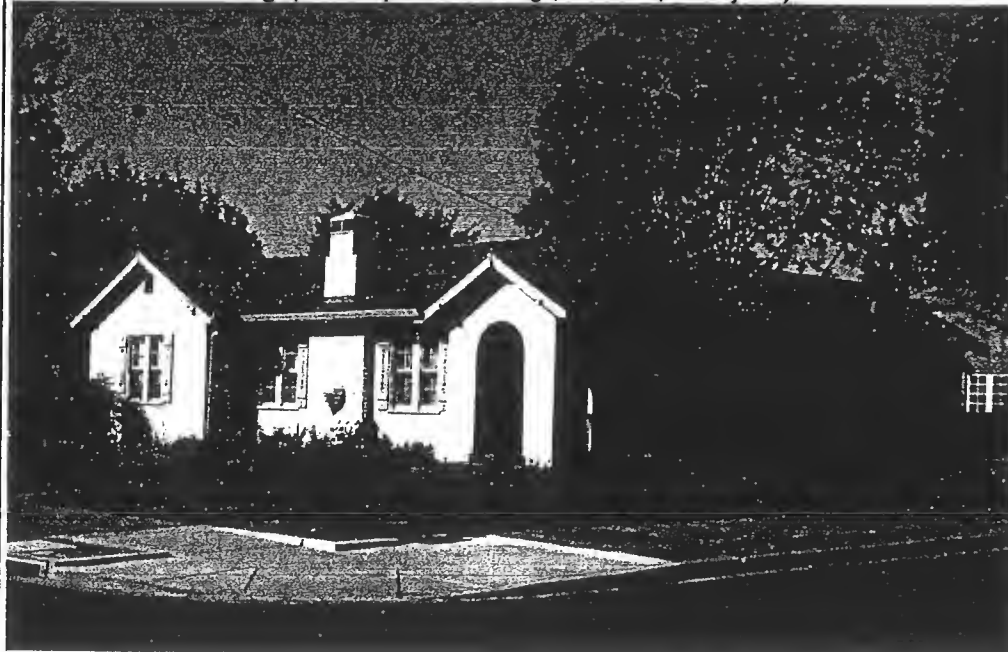
A detached garage is located on the west side of the house and features a gable roof with a wood panel garage door on the gable end facing north.

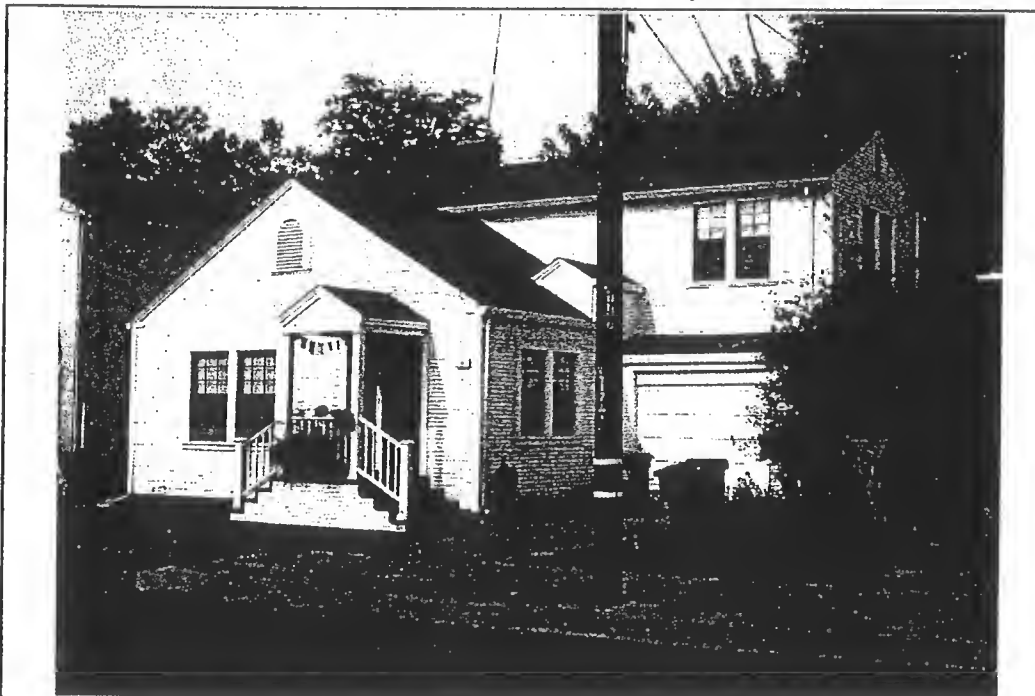
P5b. Description of Photo:  
View from Benton looking NW.

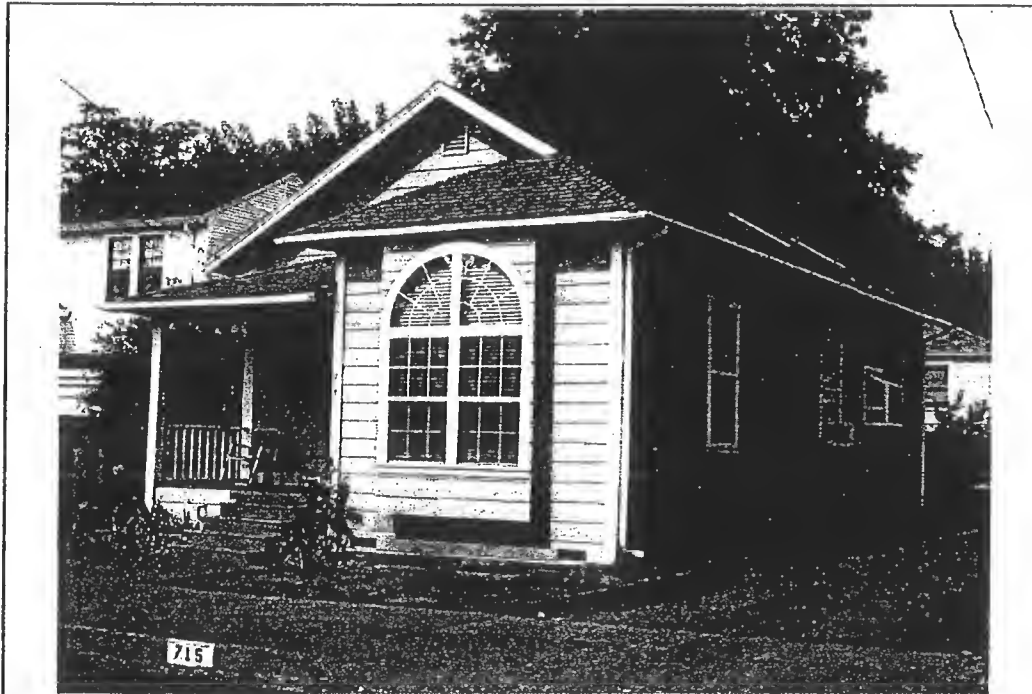
P5b. Description of Photo:  
View from Benton looking NW.  
Alley on R., 707 behind on L.

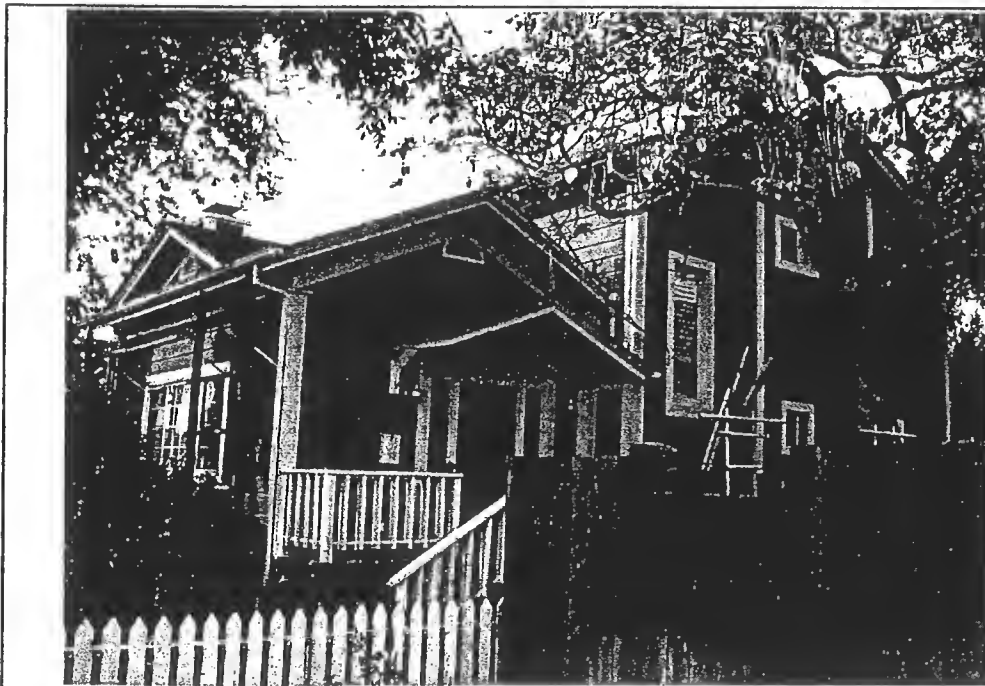
P5b. Description of Photo:  
View from Benton St looking  
NW

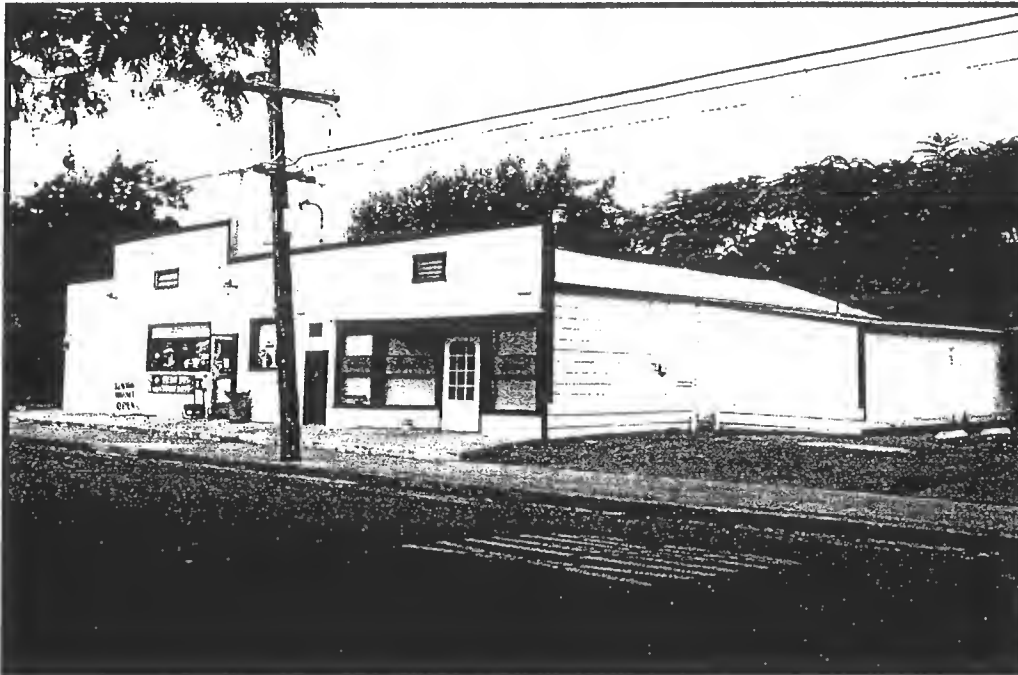
P5b. Description of Photo:  
View of 801 Benton St.,  
facing South

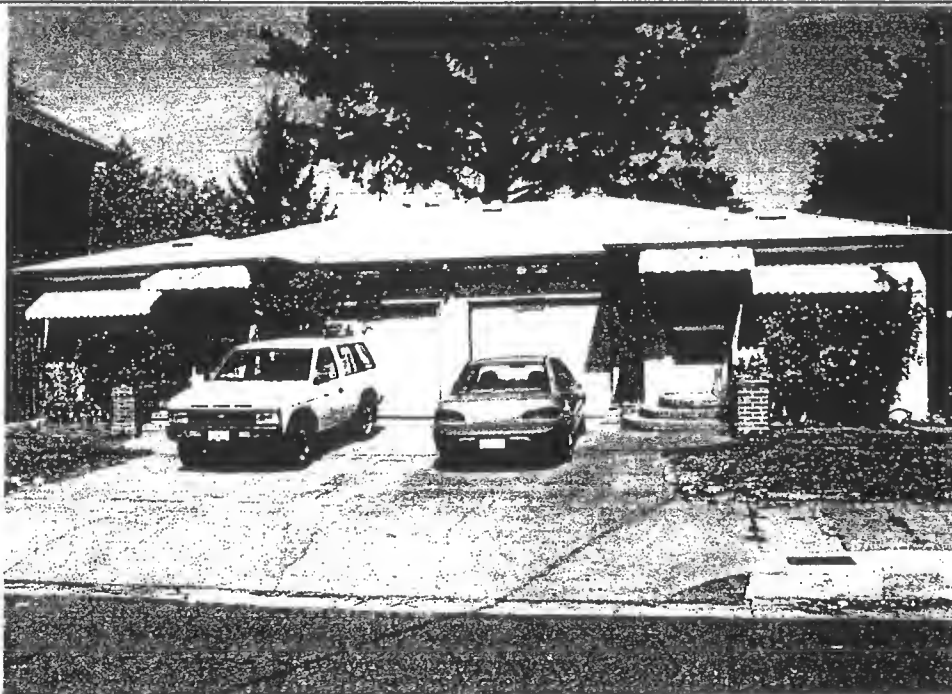
This 1956 one-story Ranch-style duplex is located just east of the intersection of Benton and Beaver streets, with the front façade facing south onto Benton street. It is wood frame construction with a perimeter concrete foundation, and a rectangular footprint. The cross-hipped roof has a shallow pitch, overhanging eaves, and is finished in composition shingles. The house has a stucco finish. It has two separate residences, which is evident in the front façade featuring two garage doors (one metal, one wood) in the recessed center of the house and a nine-panel (three tier) wood door on both east and west sides. On the left side of the left door and the right side of the right door there is a large horizontally-oriented three-light metal sash window with the center light being fixed and casement windows on each side.

P5b. Description of Photo:  
View of front façade, photo facing north

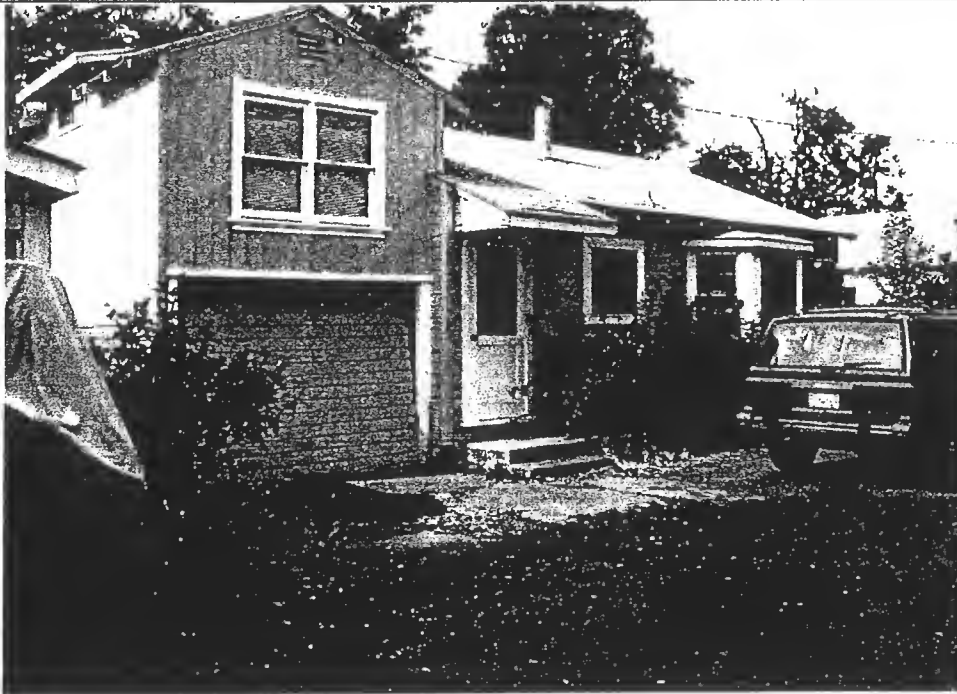
This 1930 one-story house has a two-story addition. It is located on the alley running north-south through the block bounded by Benton, Beaver, King, and Howard streets, and is immediately north of 913 Benton street with the front façade facing east onto the alley. The house is wood frame construction, with a perimeter concrete foundation and a rectangular footprint. It has a side-gable roof of moderate pitch, overhanging eaves, exposed rafters, and is finished in composition shingles. The southern portion of this house consists of a two-story front-facing gable roof with vertical wood siding. It features a wood garage door on the first story and paired one-over-one-light double-hung wood sash windows on the second story. The northern portion of this house has a side-gable roof with tongue-and-groove siding. On the southern end of this portion of the house there is a plain wood front door with concrete steps leading up to it. North of this is a one-over-one double-hung wood sash window followed by a slant-sided bay window with three horizontally oriented, two-over-two light double-hung wood sash windows. This is followed by a recessed door that is covered by an extension of the roof and is supported by a square wood post. The two contrasting portions of this house suggest that the garage is a later addition.

P5b. Description of Photo:  
View of front façade, photo  
facing northwest.

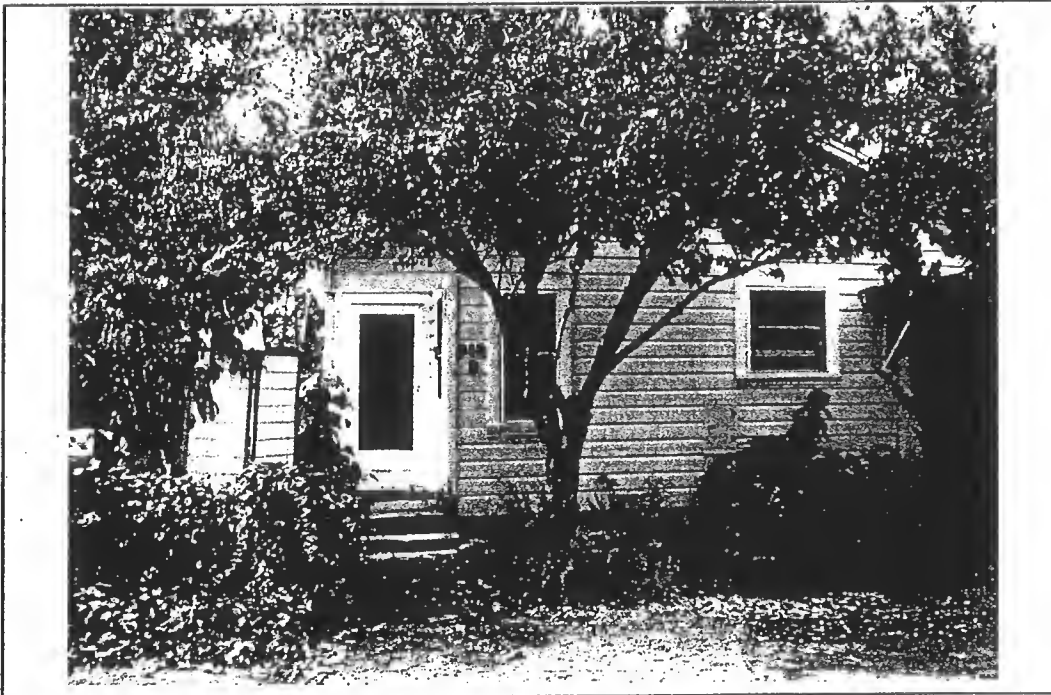
This one-story house is located in the alley running north-south through the block bounded by Benton, Beaver, King, and Howard streets, and is north of 913 Benton street and 913 A (located in alley), with the front façade facing east onto the alley. The house is wood frame construction, with a perimeter concrete foundation, a square footprint, and a front-gable roof of moderate pitch, with exposed rafters, over-hanging eaves, and composition shingles.

P5b. Description of Photo:  
View of front façade, photo facing west.

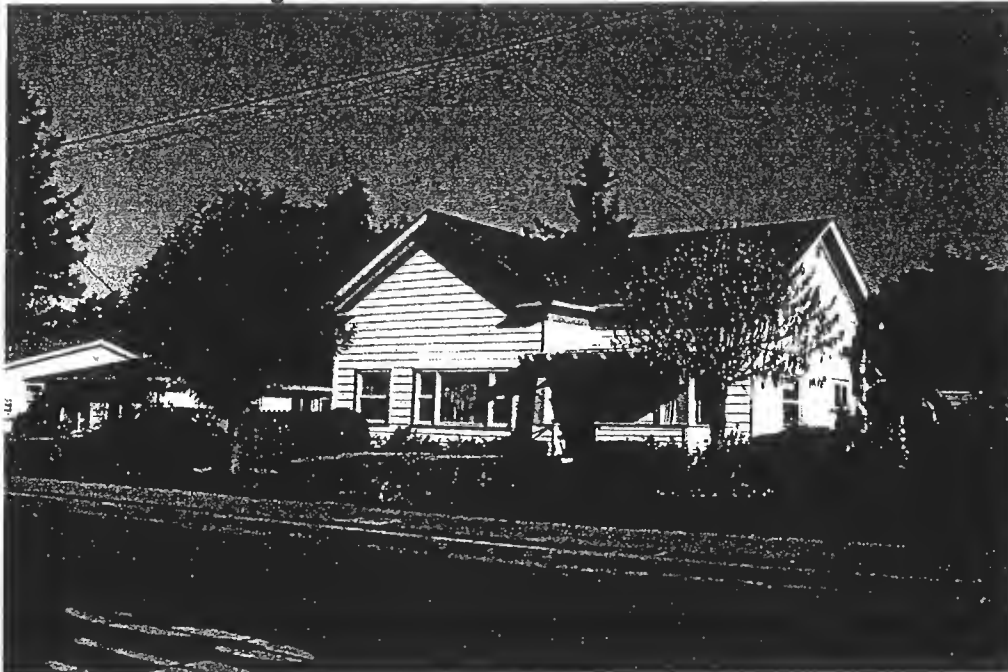
South-facing elevation, viewed from Benton St. 3 Oct 2004

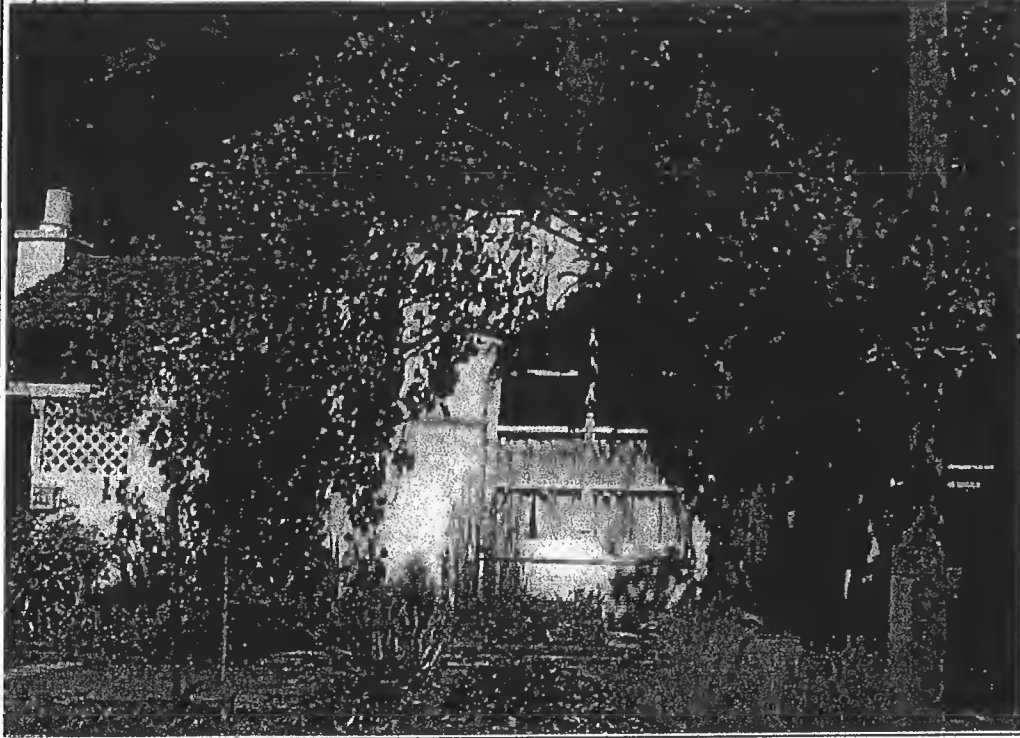
This is a one-story Mission/Spanish Revival house, constructed in 1928. It is a wood frame house with stucco exterior and cross gable roof with red Spanish tile. The house has an L-shaped footprint. It is set back a few feet from the sidewalk bounded by a small flower bed. The house has a small enclosed gated courtyard and a red tile roof. A few feet to the east of the gate is a semicircular archway that allows a view of the front door. The door faces west and has four panels and a square etched beveled glass insert, with a small stained glass window to the right of the door. The façade of the house faces south onto Howard. It has a large fixed arched front window with eight lights and a decorative mullion. An exterior chimney finished in stucco is on the west side of the house. The east and west side of the house have two aluminum one-over-one windows each. The driveway is to the left of the house with a small detached wooden garage in the back. The lot appears to be small. The overall condition of the house is good.

P5b. Description of Photo: (View, date, accession #)  
Front façade facing south on Howard

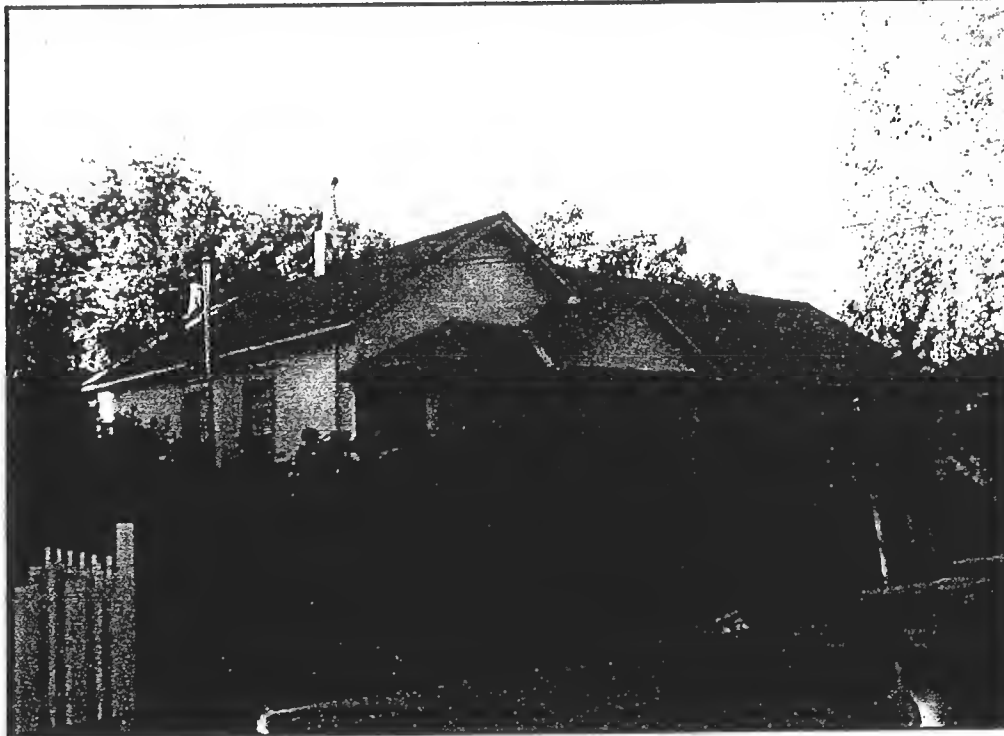
P5b. Description of Photo:  
View of 712 / 714 Howard, facing southwest, looking at 714 Howard entrance.

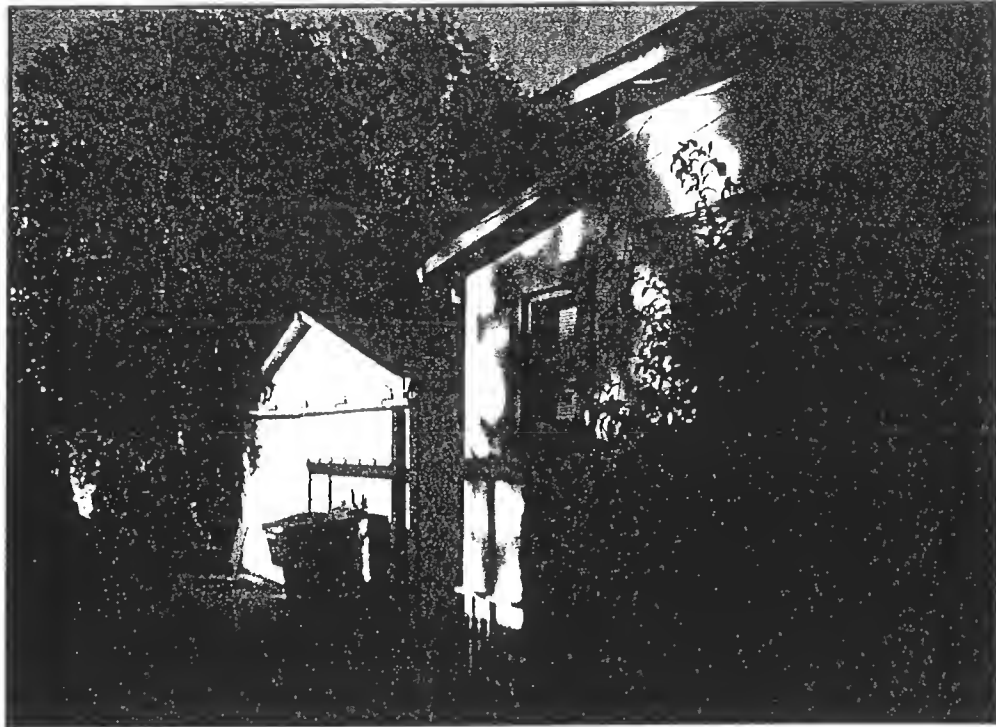
View of portion of east facade and detached building, looking southwest.

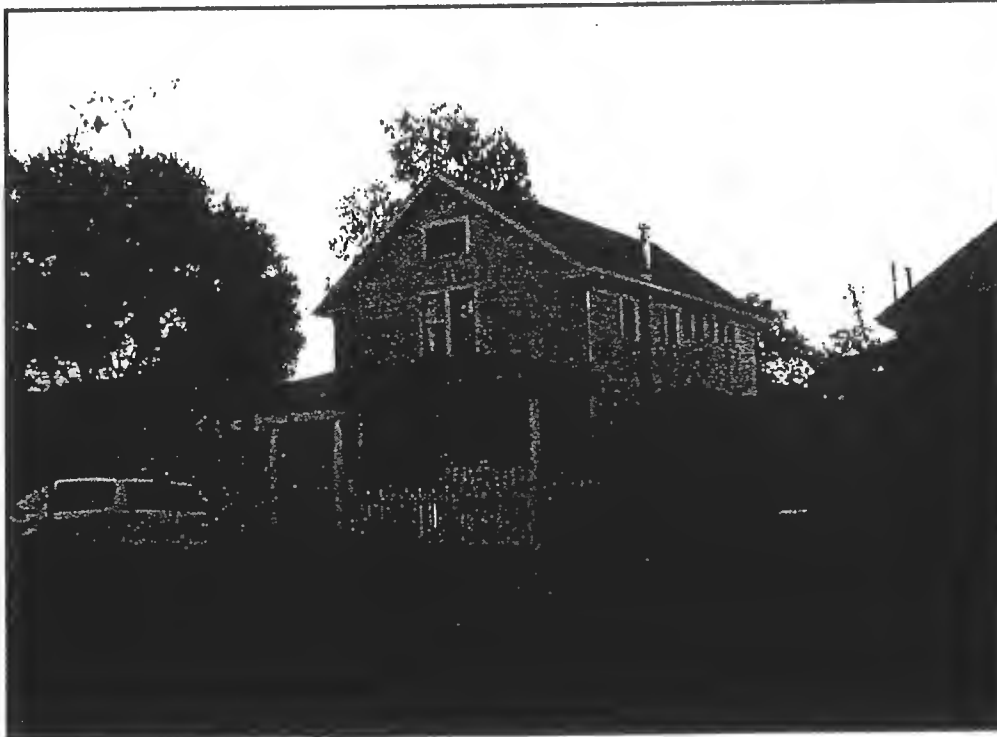
P5b. Description of Photo:  
View of 716 Howard, facing  
southeast.

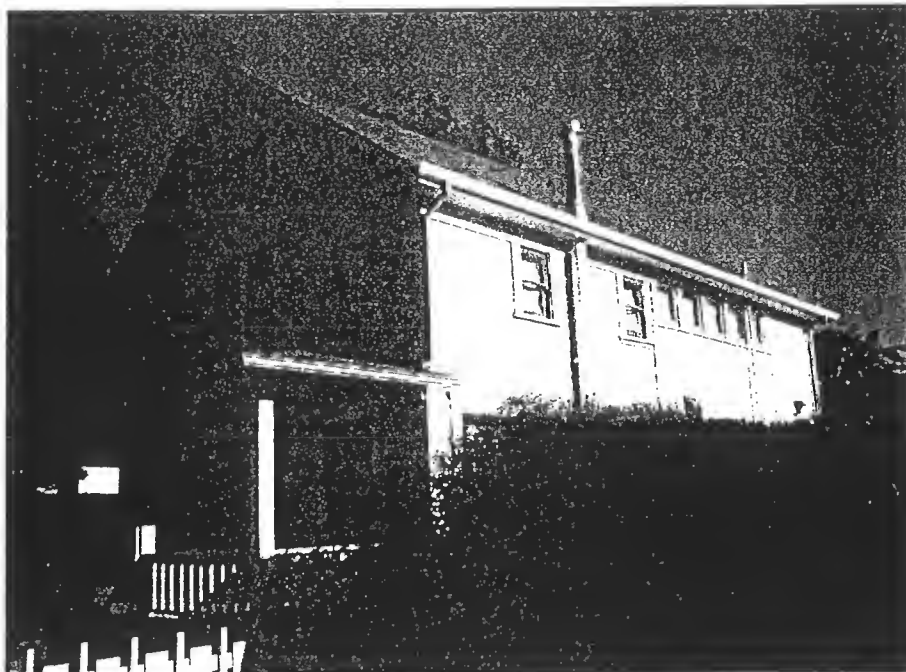
View of 716 Howard, looking southeast

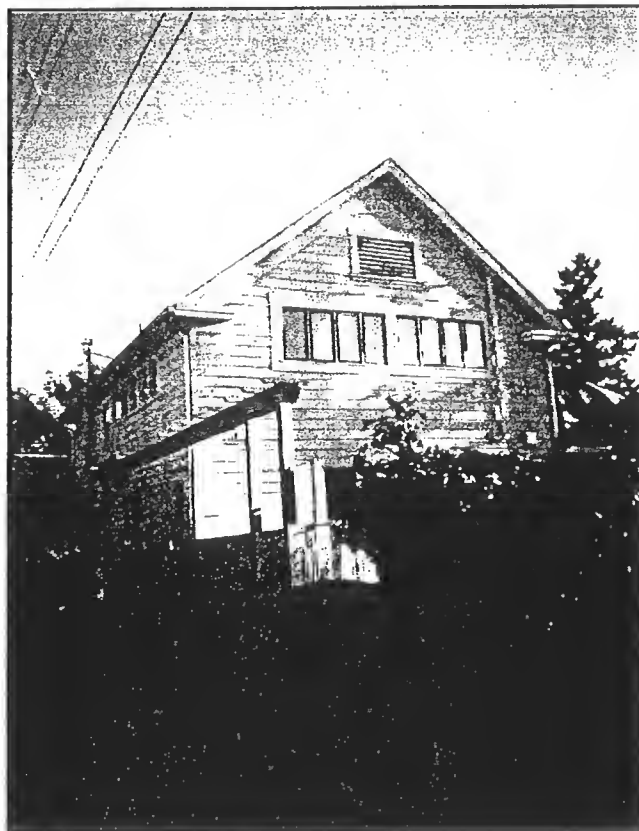
View of back of 716 Howard Street, looking north.

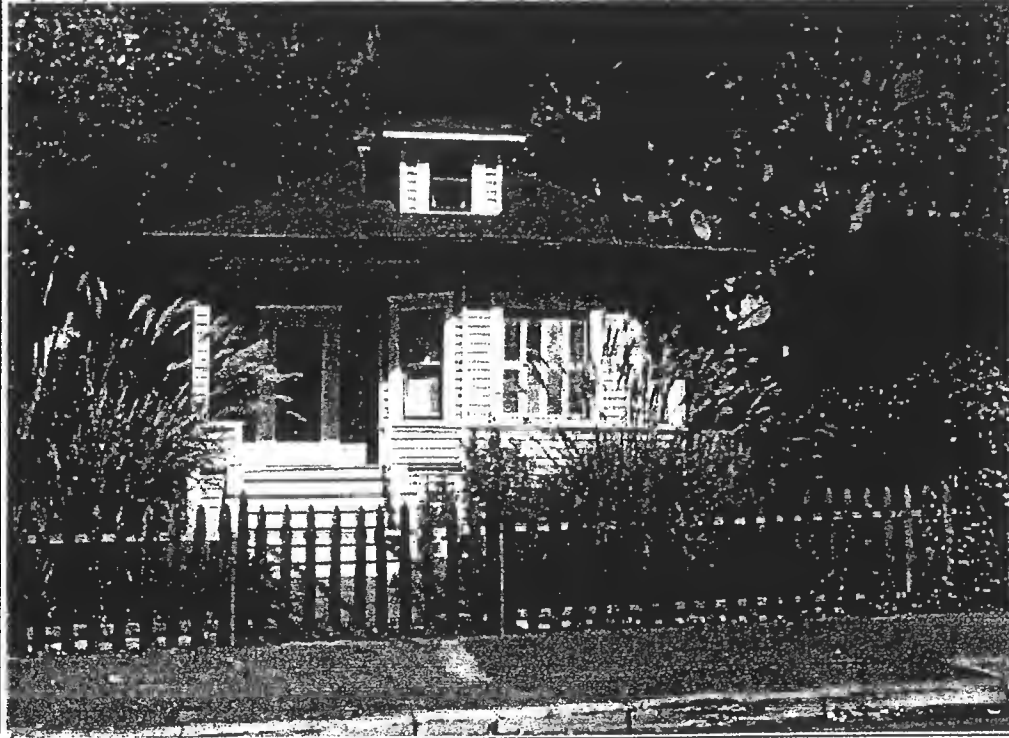
P5b. Description of Photo: (View, date, accession #)  
South elevation viewed from Howard

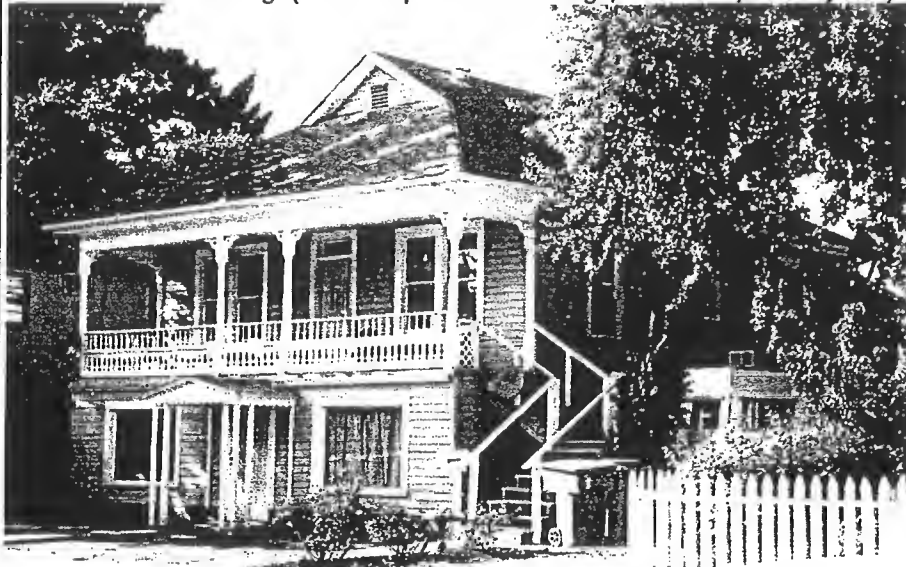
\*P3a. **Description:** (Describe resource and its major elements. Include design, materials, condition, alterations, size, setting, and boundaries)  
This ca. 1887 house (personal communication with building owner) displays Folk Victorian influences. It is a two-and-a-half story building of wood frame construction with medium width, vinyl siding. It has a square footprint and a gable-on-hip roof of composition shingle and second story full-length porch. Bloomfield (1990) considers this Italianate ca. 1880; personal communication with owner suggests 1887. There is a 4' x 24' rectangular unit attached at the rear of the house. The first story was added after the 1906 earthquake (personal communication with owner, descendent of original owner). There is a doorhood gable, supported by eight, thin square posts above the first story door situated in the center. There are projecting eaves with plain, boxed cornice. Windows are a combination of single fixed one sash, fixed on the first story, and two double-hung windows with sash divided vertically on the second story. All windows are flat with plain molding. There are single wood doors with screen and wire mesh doors situated in the center on both stories. Both wood doors have two panels, the top panel is a light. The doors have plain molding with no surrounding detail. Leading to the second story are open railing stairs with a straight, reversed approach to a porch with four rounded columns having decorative brackets and square bases. The wood railing along the extent of the porch is about 2 foot high and divided in half horizontally, the bottom of which is decorative and appears original, the top half was added later.

P5b. **Description of Photo:** (View, date, accession #)  
Oblique view to the northwest taken September 20, 2004
